THE SHORES PHASE 1 SUBDIVISION - SITE MONITERING PROGRAM

Period: July 14th to July 20th

Date: 07/20/2018 File Number: 3341-79 (2015 Sinkhole) Inspector: Adam Bullock, EIT Recent Rainfall: 0.0 mm in the past 7 days

THE SHORES PHASE 1 SUBDIVISION - SITE INSPECTION REPORT

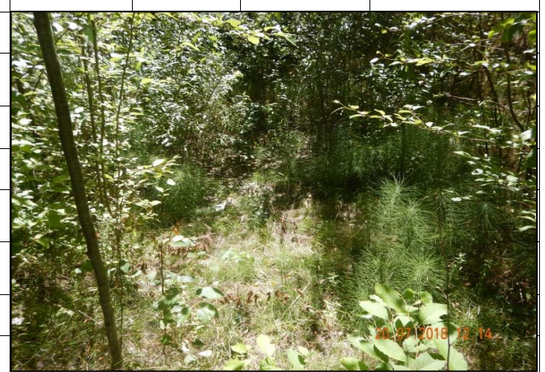
Photo File #	
Item #	
Location:	Lot 3 outlet
Comment:
