THE SHORES PHASE 1 SUBDIVISION - SITE MONITERING PROGRAM

Period: September 1st to September 10th

Date: 08/31//2018 File Number: 3341-79 (2015 Sinkhole) Inspector: Adam Bullock, EIT Recent Rainfall: 15.2 mm in the past 7 days

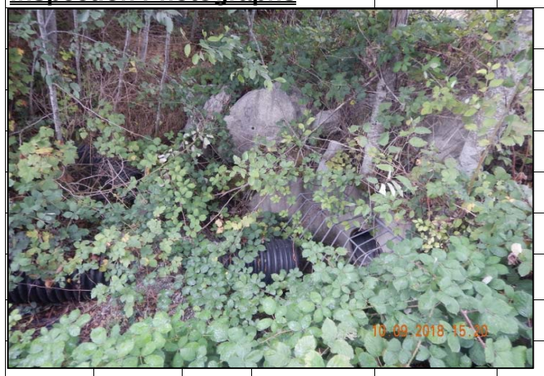
Photo File #	
Item #	
Location:	Crowston Ditch
Comment:
