THE SHORES PHASE 1 SUBDIVISION - SITE MONITERING PROGRAM

Period: December 22nd to January 2nd

Date: 01/02/2019 File Number: 3341-79 (2015 Sinkhole) Inspector: Adam Bullock, EIT Recent Rainfall: 63.7 mm in the past 7 days

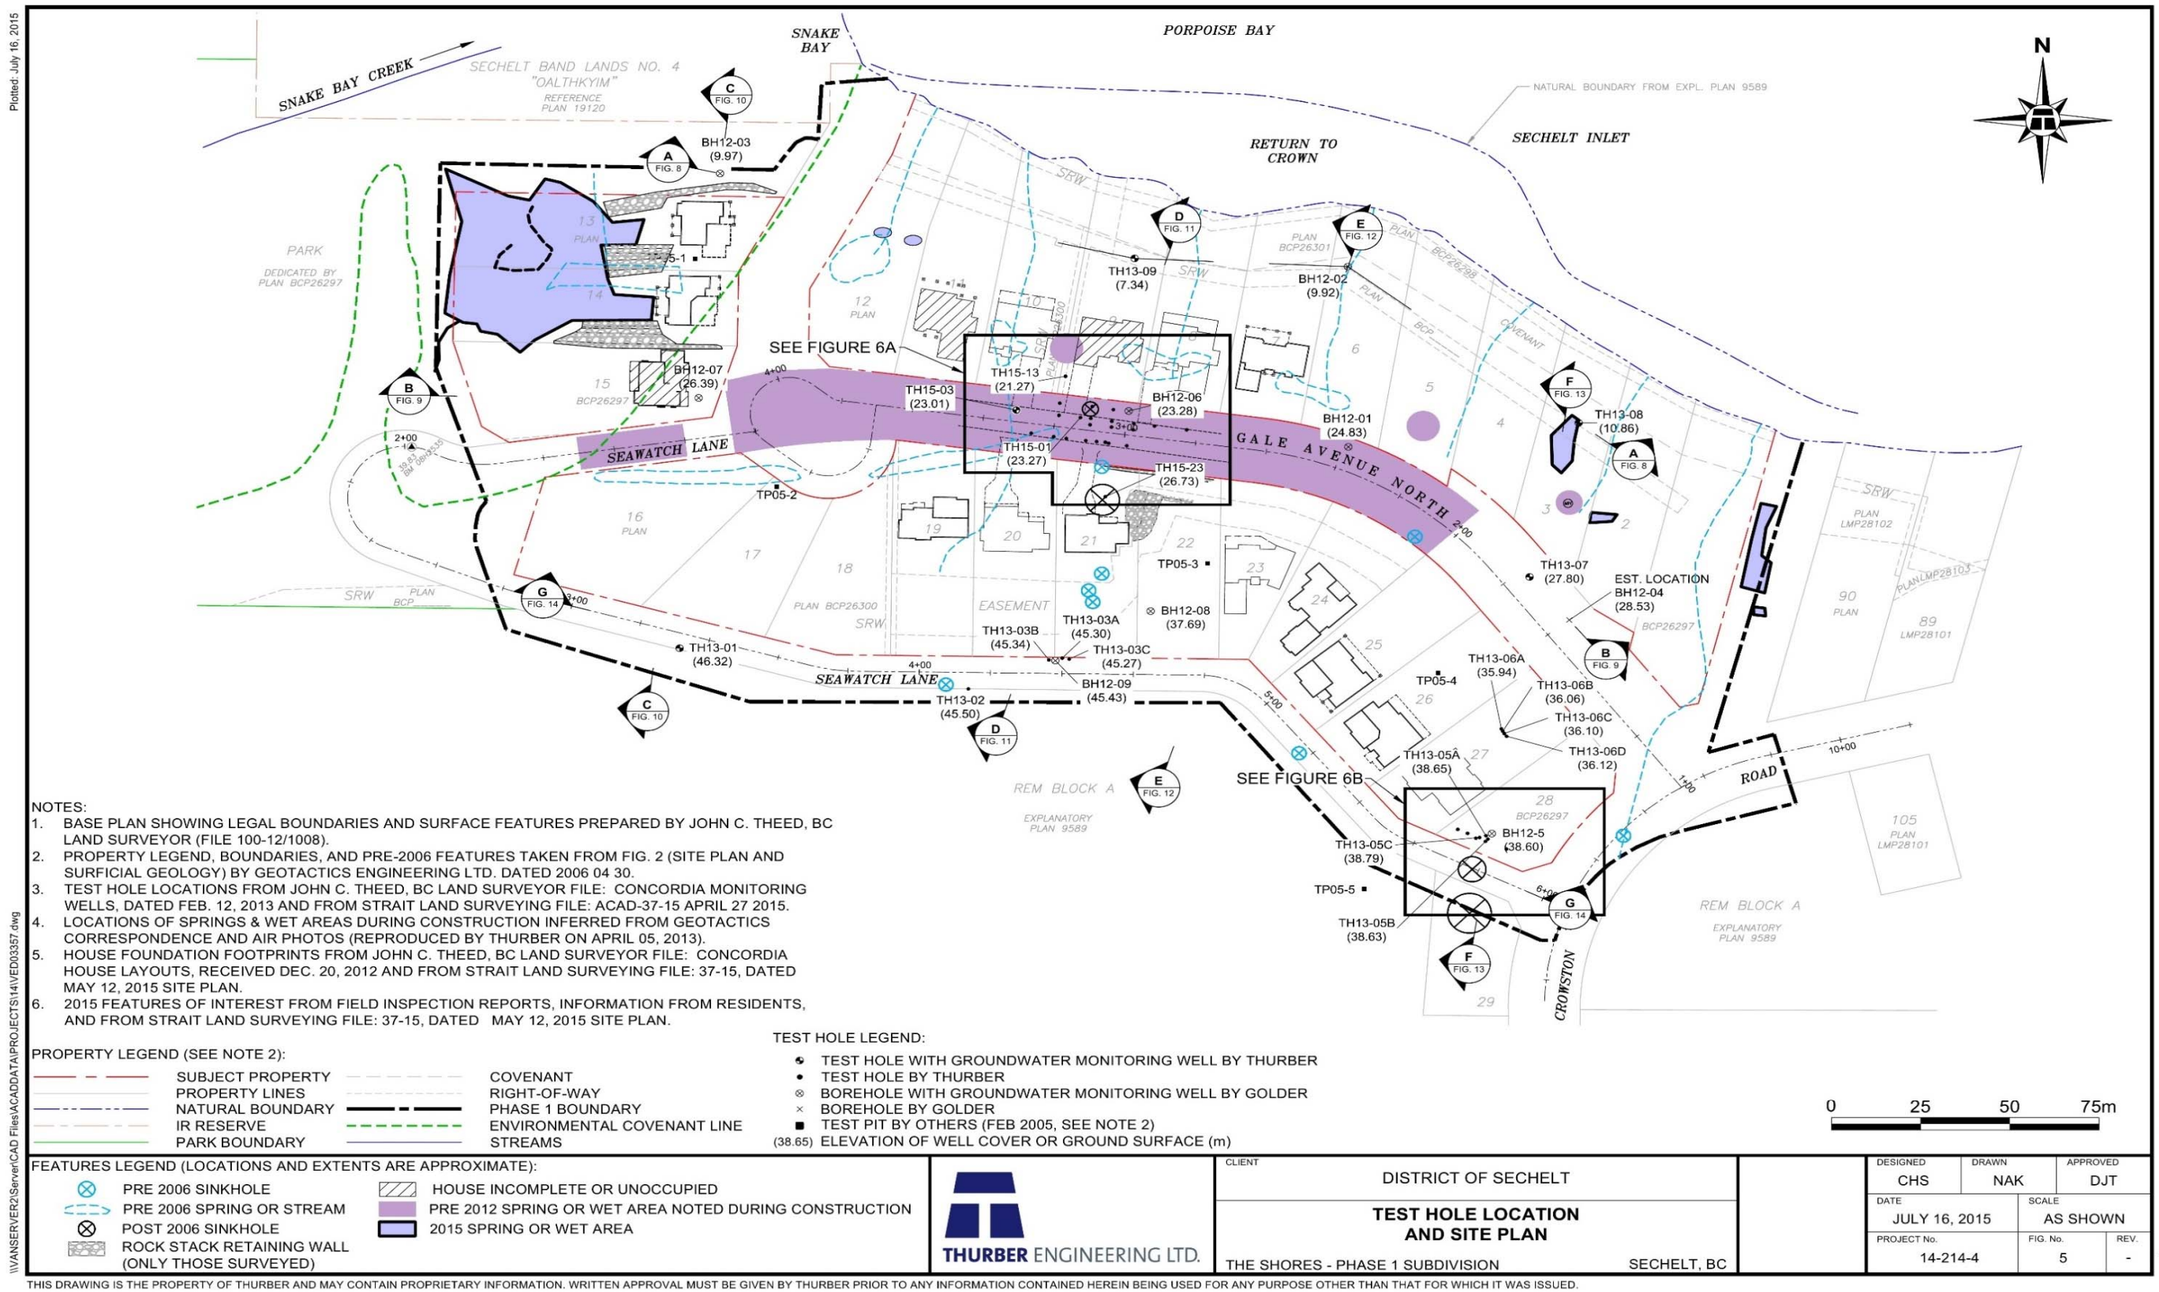
Developments since last inspection: No visible significant changes to District infrastructure from last inspection - evidence of sinkhole on pirvate property south of Seawatch Lane in proximity to District roadway

23	Seawatch Lane at Lots 15 - 23	Cracking/settlement of asphalt/curbs?	Yes	Evidence of sinkhole which occurred during last inspection period within private property south of Seawatch Lane - located south of Lot 22 - extent and impacts not determined during inspection as property owner had backfilled the hole
24	Lot 22	Status of apparent scarp at south end of lot	No	No visually apparent changes since last inspection
25	Lot 22	Any new erosion/rilling, settlement/depressions, springs?	No	No visually apparent changes since last inspection
26	Rock Stack Walls at Lots 22 to 24	Signs of instability, distress	No	No visually apparent changes since last inspection
27	Seawatch Ln at cut slope (Sta. 2+20 to 2+60)	Status, signs of instability, major recent erosion?	No	No visually apparent changes since last inspection
28	Path east of Lot 1	Wet areas / springs / seeps	No	Pathway saturated with surface runoff flowing along
