THE SHORES PHASE 1 SUBDIVISION - SITE MONITERING PROGRAM

Period: Sep 29th to October 6th

Date: 10/06/2017 File Number: 3341-79 (2015 Sinkhole) Inspector: Adam Bullock, EIT Recent Rainfall: 23.8mm in past 7 days

THE SHORES - PHASE 1 SUBDIVISION — SECHELT, BC

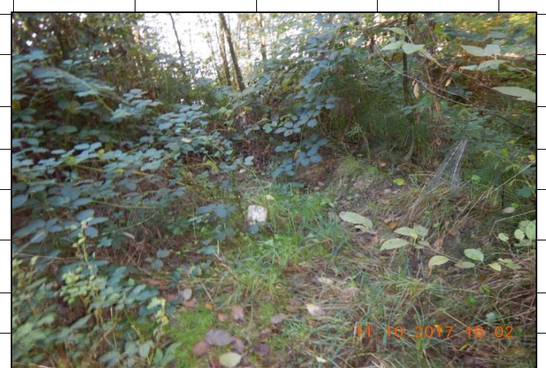
Photo File #		Item #		Photo File #		Item #		Photo File #		Item #		Photo File #		Item #
Location:	Borrow			Location:	Crowston Ditch Inlet			Location:	Lot 12 Ponding			Location:	Lot 9/10 outfall	
Comment:	Minimal ponding			Comment:				Comment:				Comment:

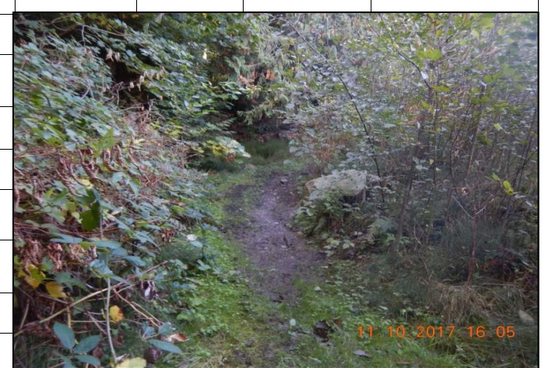
Photo File #		Item #		Photo File #		Item #		Photo File #		Item #		Photo File #		Item #
Location:	Settling Pond 1			Location:	Settling Pond 2			Location:	Lot 1 Outfall			Location:	Lot 1 Pathway	
Comment:				Comment:				Comment:				Comment:

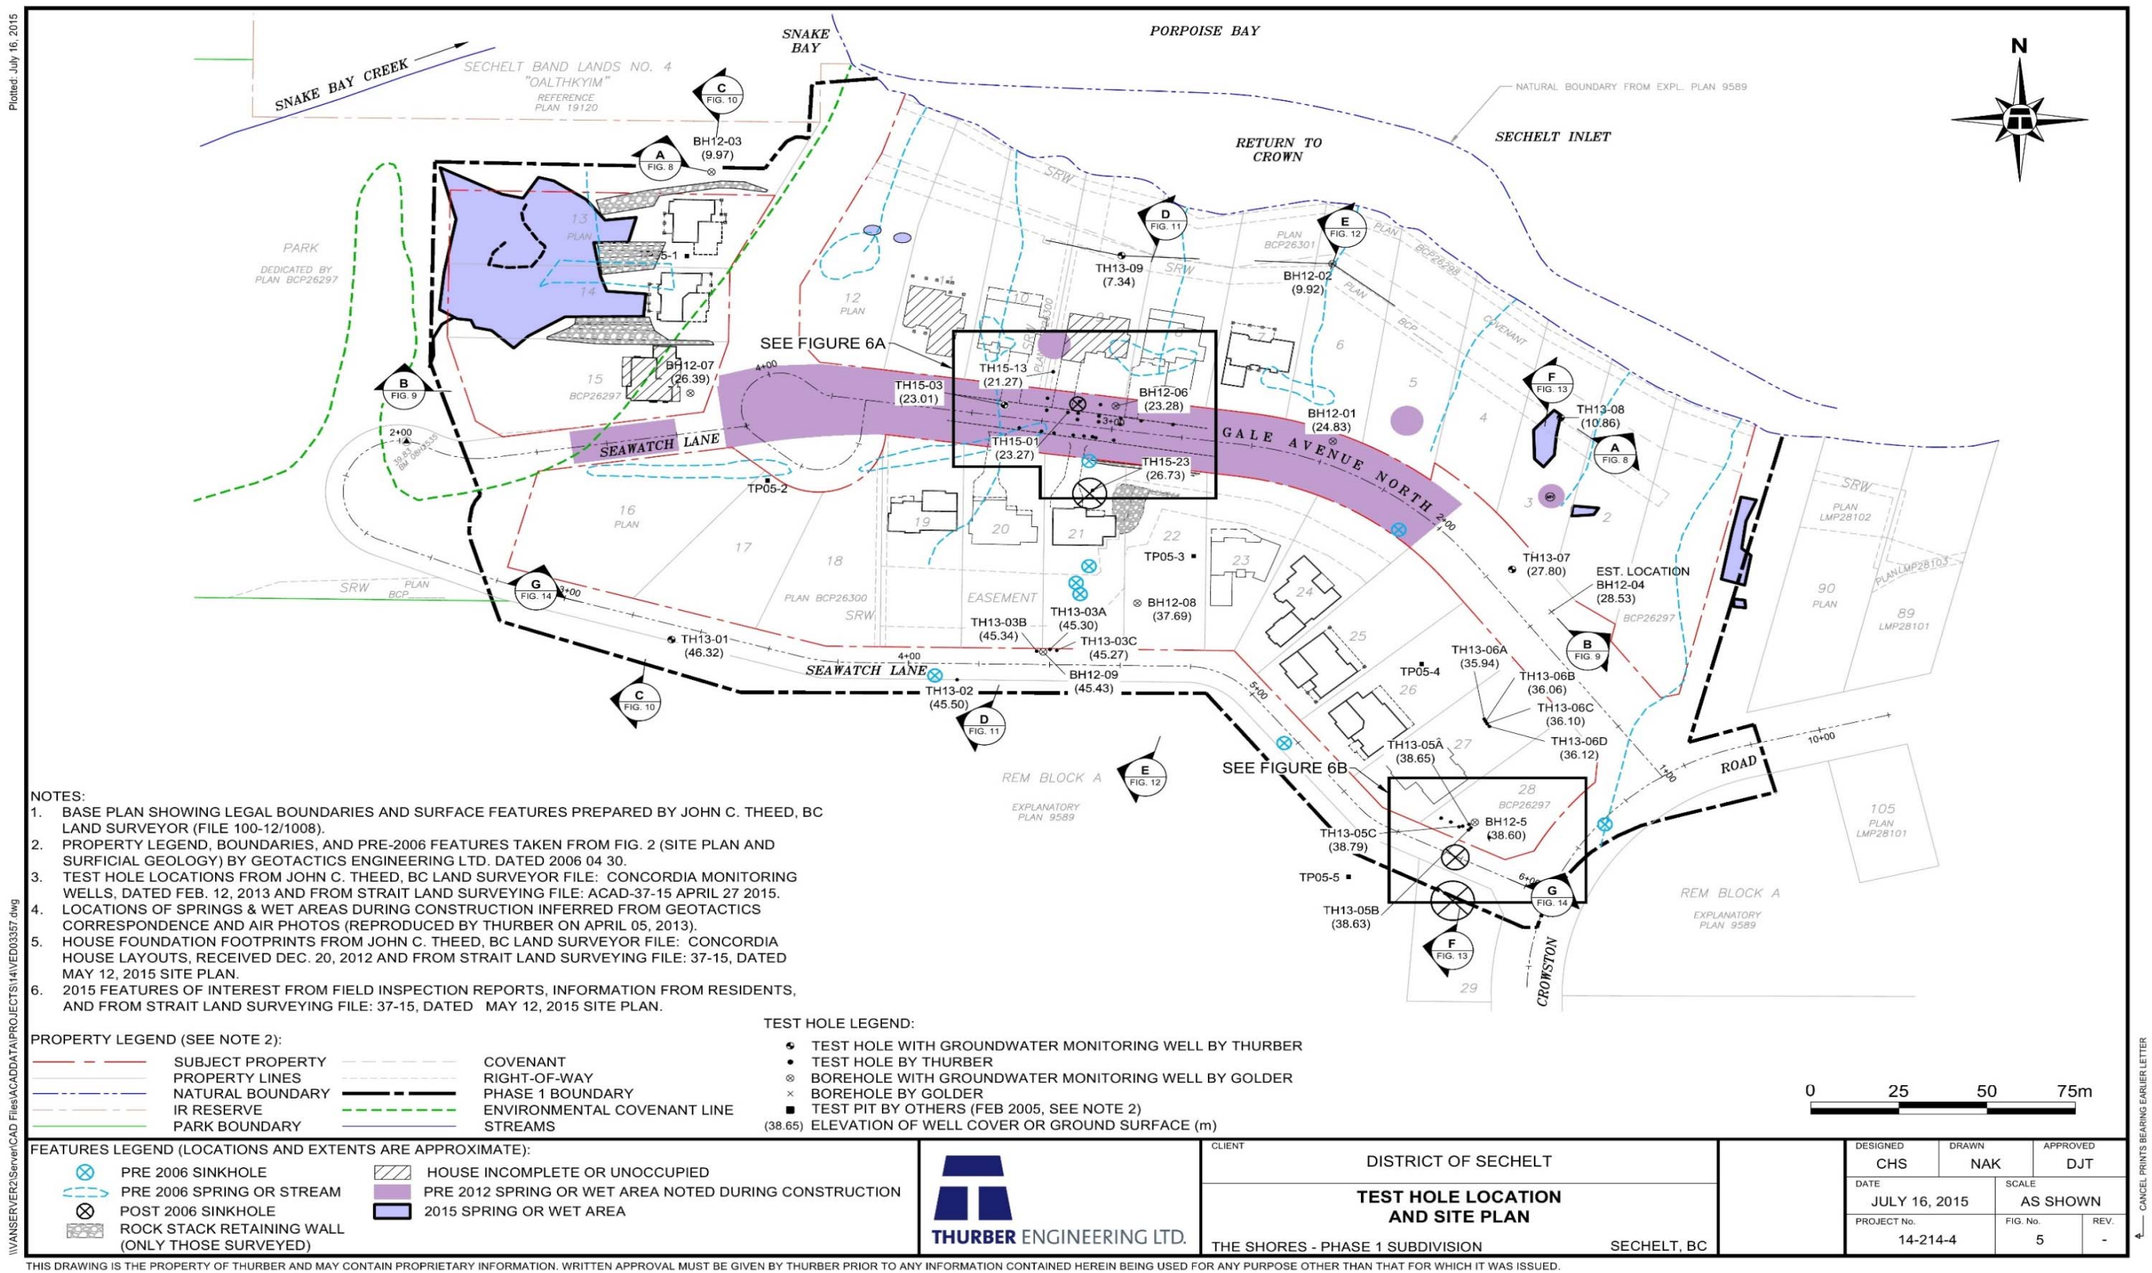
January 13th, 2017				9.11						4.9				7.41	Most covers Borehole
June 16th, 2017	5.32	3.04	2.26	8.44	7.95	4.9	Burried	16.377	14	4.58		0.88	1.04	7.41	13-08 & 12-
July 31st, 2017	5.95	3.09	2.33	8.82	7.98	5.01	11.85	17.03	14.62	4.97	2.5	1	1.08	7.42	
September 22nd, 2017	5.3	3.09	2.29	9.21	8.01	5.04	burried	17.34	DRY	5.11		6.82	1.14	7.39	13-08 under water, 12-08 burried, will bring shovel
September 29th, 2017	5.25	3.05	2.32	9.25	7.98	5.03	Burried	17.38	DRY	5.14		0.94	1.09	7.4	13-08 underwater, 12-08 burried
October 6th, 2017	5.15	3.1	2.3	9.22	8	5.03	11.49	17.37	DRY	5.08		0.9	1.08	7.42	
October 13th, 2017	5.3	3.11	2.11	9.35	7.98	5.03	11.53	17.38	DRY	3.05		0.61	1.09	7.4	Cap missing from 13-07 and chamber was flooded,13-08 underwater

Photo File #		**Item #**			**Photo File #**			**Item #**		**Photo File #**			**Item #**		**Photo File #**			**Item #**
Location:	**13-07**				**Location:**					**Location:**	**Lot**				**Location:**			
Comment:	**Flooded chamber**				**Comment:**					**Comment:**					**Comment:**

Photo File #		**Item #**			**Photo File #**			**Item #**		**Photo File #**			**Item #**		**Photo File #**			**Item #**
Location:	**Lot 21**				**Location:**	**Lot 21 Stairs**				**Location:**	**Lot 10**				**Location:**			
Comment:					**Comment:**					**Comment:**					**Comment:**
