## DPA 4 – Rocky Beach Front/Escarpment, Rockfall and Upland Slope Hazards

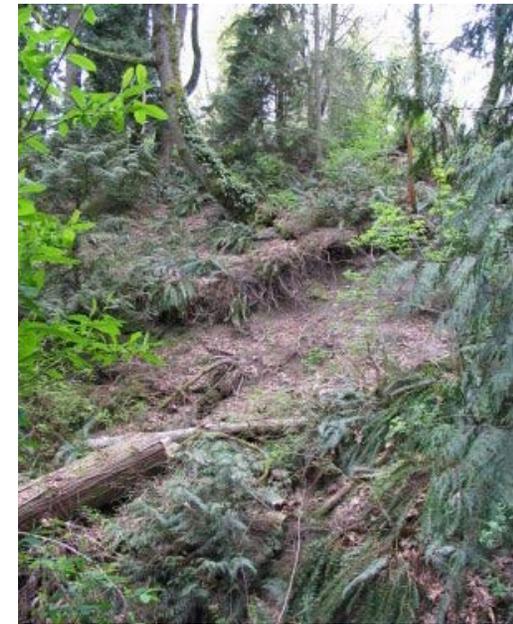
✘ *Unstable soils on upland slope.*

The soils are subject to potential shallow instability, small debris landslides and to minor storm wave erosion where they are exposed along the beachfront. Creep and shallow instability in the surficial soils have been observed.

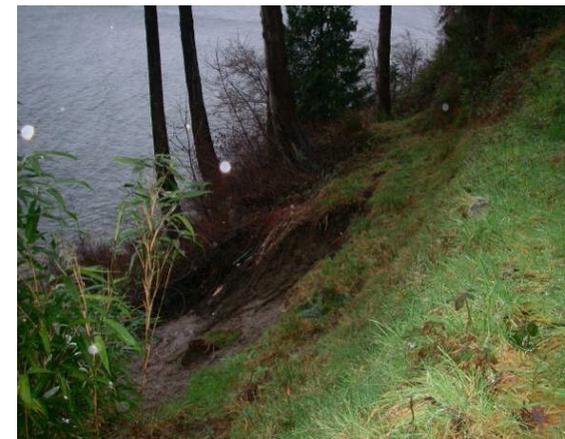
✘ *Recent slope failure in Davis Bay/Selma Park after heavy rains.*
